# Moncrieff B4 S23 Site Investigation Report

**Prepared for:**  
**The Suburban Land Agency (SLA)**

**16 August 2024**

Document Title:	Moncrieff Block 4 Section 23 Site Investigation Report
Document Ref:	2024-034
Prepared For:	The Suburban Land Agency (SLA)

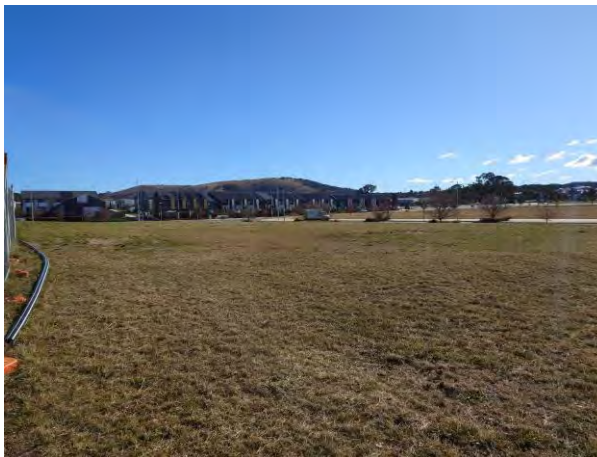
**Figure 6 – General Site Photo of the Subject Site Looking North West**

The photos taken in Figure 6 to Figure 9 provide a general overview of the site from different visual aspects, including a future development sign. The photos provide an indication of the site's current condition, topographical features, and some of the existing trees surrounding the site.

During a site inspection, it was observed that the topography of the site is evenly graded from the south west corner to the north east corner of the site boundary with an average approximate grade of 3.0%. The differing grades within the subject site when compared to the surrounding development and roads, suggest significant regrading activities may have occurred on the site as part of the estate works.

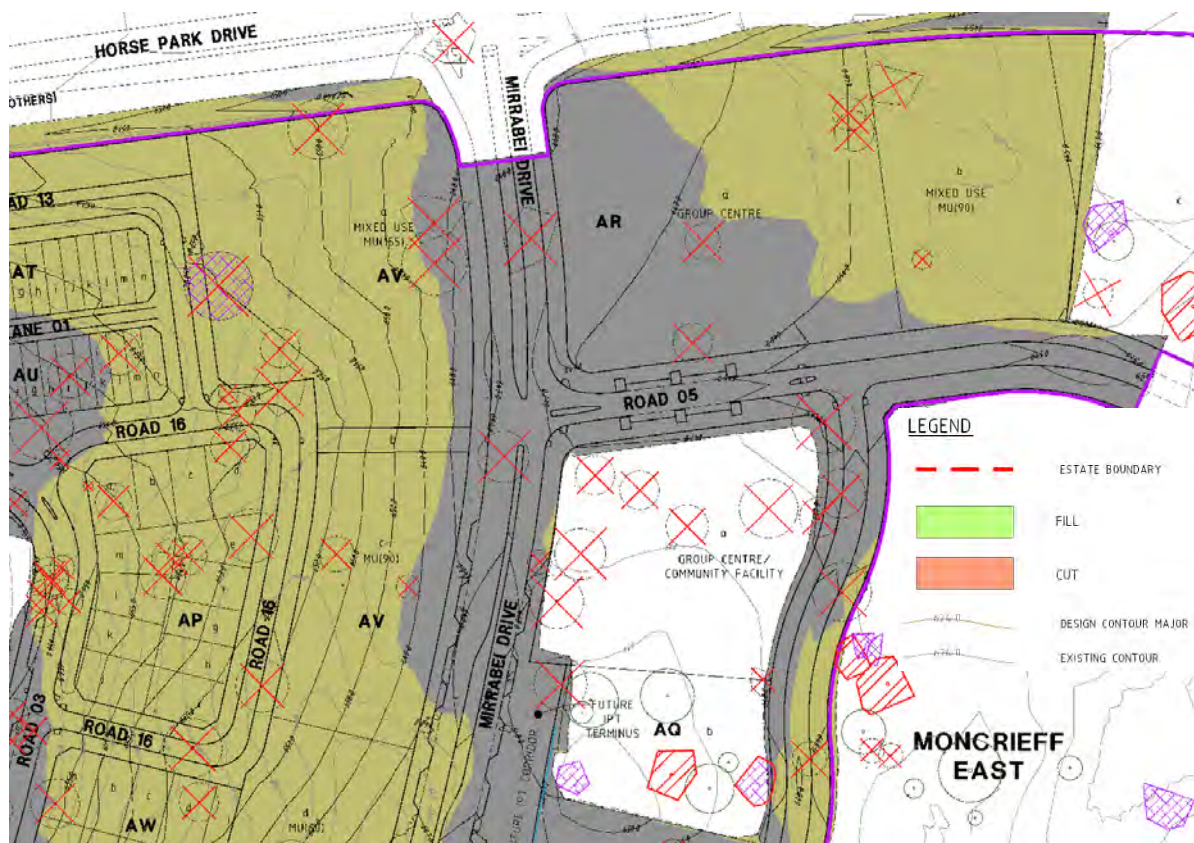
Figure 13 – Cut and Fill EDP Plan (Brown Consulting, 2014)

A geotechnical investigation was run concurrently with the EDP submission and was used for the detailed design phase of the estate. The estate design generally follows the site's natural grading, minimising cutting and filling proposed as part of the estate design. Preliminary cut and fill extents can be seen in Figure 13 below, taken from the 2014 EDP drawings.

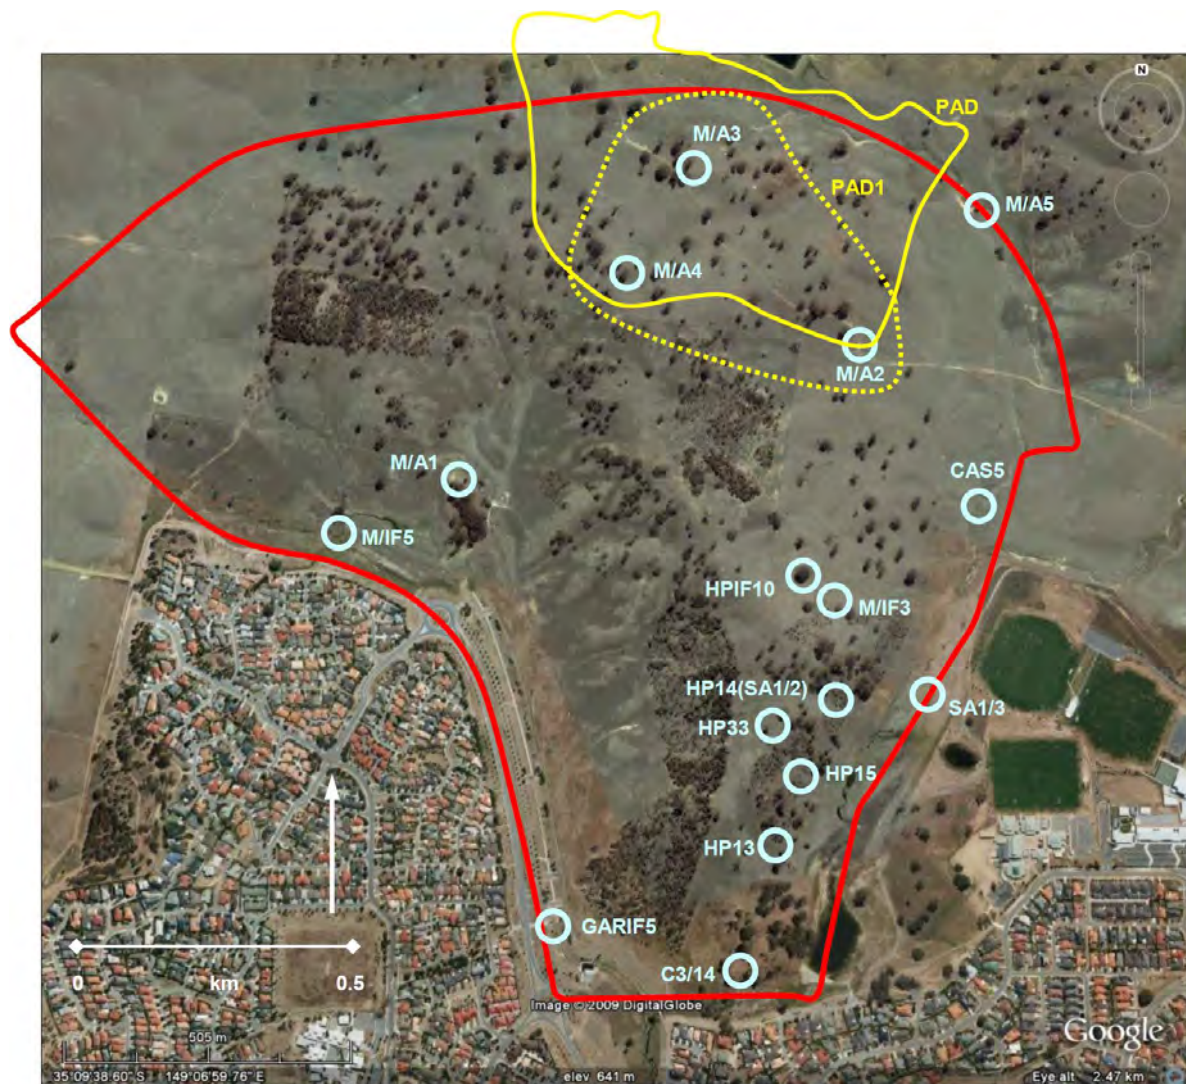
Figure 16 – Locations of Recorded Aboriginal Sites and PADs within Moncrieff (Navin Officer, 2010)

Refer to Figure 16 below for an extract of the abovementioned locations of previously recorded Aboriginal sites and PADs within the NOHC Moncrieff study area.

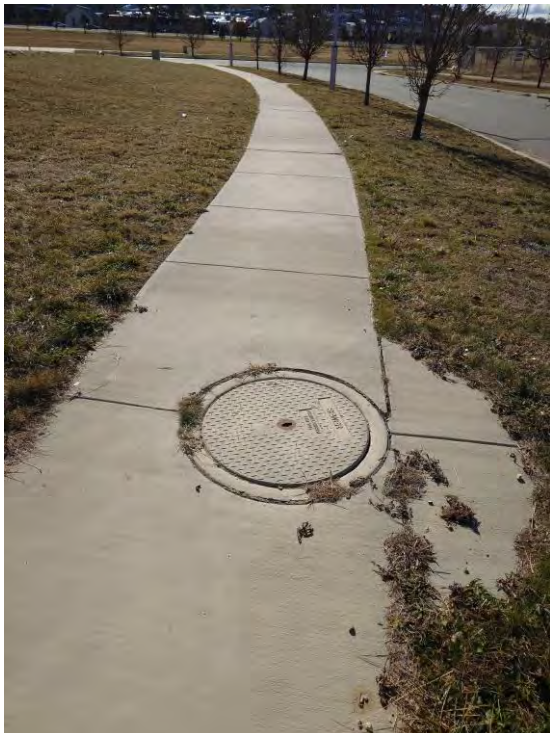
Figure 19 – Sewer Manhole in West Verge of Hoffmann Street South East of Site

The BYDA information indicates that there is a sewer tie connection to Block 4 Section 23 Moncrieff, located at the north east corner of the block, which is its lowest point. During the subdivision of Blocks 4 and 5 Section 23, a new DN150 sewer main was installed along the west verge of Hoffmann Street, extending beyond the subject site and terminating just past its southern boundary, where a DN150 service tie is provided to Block 5. Sewer manholes over the main to the immediate east of the subject site were located during a site inspection. See photos in Figure 19 and Figure 20 of several of these manholes as observed on site.

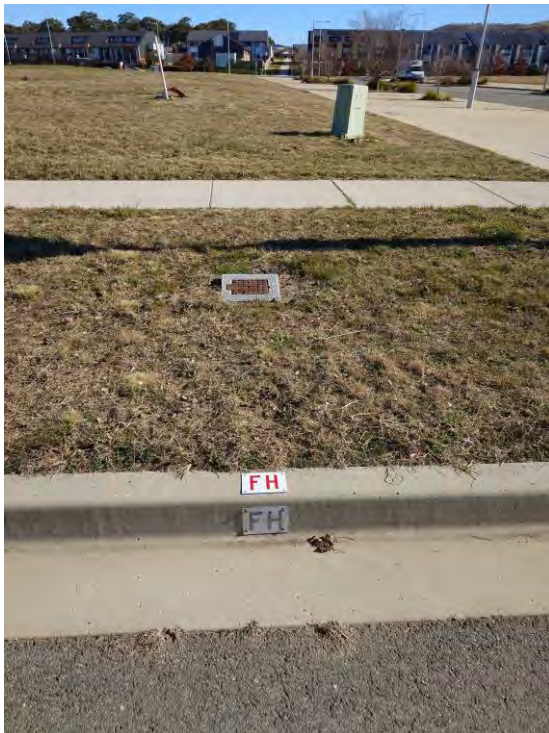
Figure 23 – Hydrant in West Verge of Hoffmann Street North East of Site

A DN150 water main is located in the southern verge of O’Keefe Avenue, adjacent to the subject site’s northern boundary. This main includes two hydrants spaced approximately 63 to 65m apart, positioned north of the site. The DN150 main connects to another DN150 water main running just behind the western kerbline of Hoffmann Street. Along Hoffmann Street, the DN150 main has two hydrants located east of the subject site, spaced at approximately 48m and 32m from the nearest hydrant in O’Keefe Avenue along the main. Refer to Figure 24 and Figure 25 for photographs of the fire hydrants north east and north west adjacent the site’s northern boundary, respectively. Additionally, the photo in Figure 23 below shows a hydrant located in Hoffman Street, east of the site.

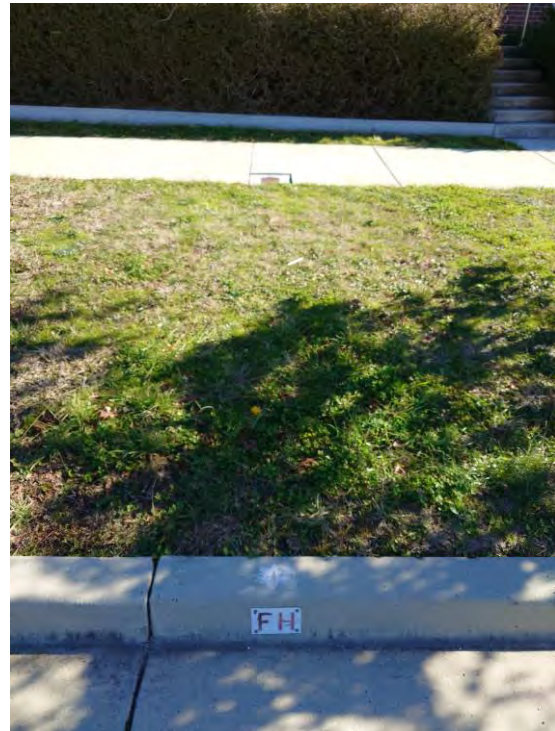
**Figure 26 – Hydrant in West Verge of Mirrabei Drive South West of the Site**

To the west of the subject site, a DN150 water main is also present in the west verge of Mirrabei Drive, with hydrant spacing on this main between 51 and 59m. Figure 26 shows a photo of a hydrant that was located in Mirrabei Drive, south west of the site. The DN150 main running along the western verge of Hoffmann Street crosses O’Keefe Avenue at the intersection, where it has a 90 degree bend and continues east along the northern verge of O’Keefe Avenue.

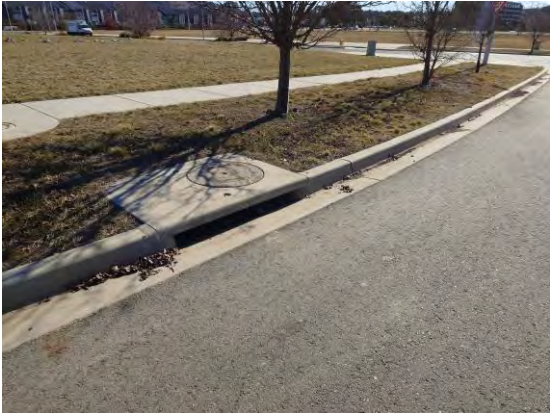
**Figure 29 – Stormwater Sump in West Verge of Hoffmann Street East of Site**

A high point in Hoffmann Street is located approximately 85 meters south of its intersection with O’Keefe Avenue. A DN300 pipe and sump network conveys stormwater flows from the road toward the previously mentioned DN750 main in the centreline of O’Keefe Avenue. Figure 29 shows a photo of a kerbside sump in Hoffman Street, east of the site. At the junction of the Hoffmann Street pipe connection, the DN750 main again upsizes to a DN900 stormwater main, which extends east where through a splayed bend in the pipe, changes direction to the north toward the open space corridor (Block 2 Section 80 Moncrieff), north east of the subject site. Access to this open space area is provided via a driveway off O’Keefe Avenue, leading to a gross pollutant trap (GPT) located approximately 20 meters north of O’Keefe Avenue. The GPT features a hardstand service area for maintenance access. A DN900 stormwater pipe discharges from the GPT and continues north east, crossing Horse Park Drive and continuing to convey stormwater flows to the north east. See below Figure 31 and Figure 33 for photos of the access gate to the GPT from O’Keefe Avenue and the GPT, respectively.

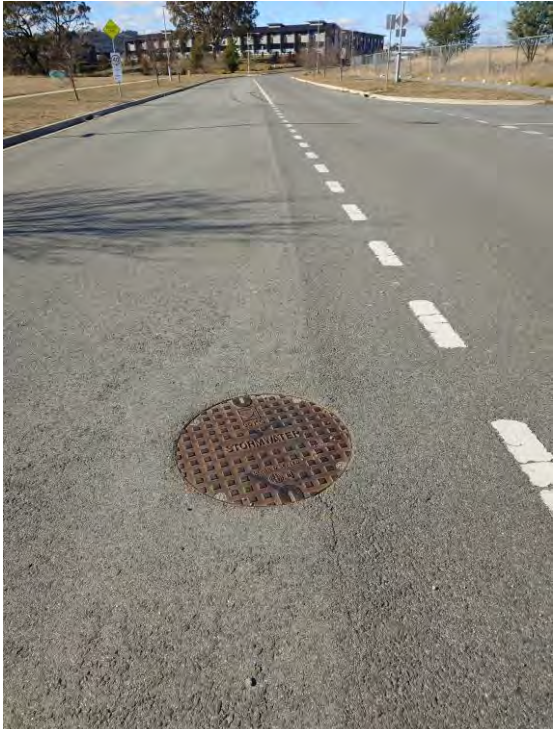
**Figure 32 – Stormwater Manholes in O'Keefe Avenue North East of the Site**

Stormwater infrastructure surrounds the subject site, with a network of kerbside sumps and pipes located along the adjacent roads. A DN300 and DN375 pipe network is present on Mirrabei Drive, approximately 95m north of its intersection with O’Keefe Avenue. Similarly, a DN300 and DN375 pipe network with kerbside sumps exists south of the O’Keefe Avenue intersection on Mirrabei Drive, with a high point located approximately 65m south of the intersection. This stormwater network, which drains both the road and adjacent developments, crosses Mirrabei Drive via a DN675 pipe and continues east along the southern verge of O’Keefe Avenue. A stormwater sump on O’Keefe Avenue, where this DN675 pipe connects to can be seen in Figure 30. At the intersection of O’Keefe Avenue and Hoffmann Street, a DN375 stormwater tie is provided at the southeast corner of the subject site. According to WAE information, this tie has a grade of 4.24% and is approximately 2.04 meters deep at its end. At this point of connection, the DN675 stormwater main in O’Keefe Avenue increases to a DN750 pipe, which deflects from its alignment at the back of the kerb to the centreline of O’Keefe Avenue and continues to the east. The stormwater manhole in the centreline of O’Keefe Avenue at this upsizing of pipe can be seen in Figure 32 below.

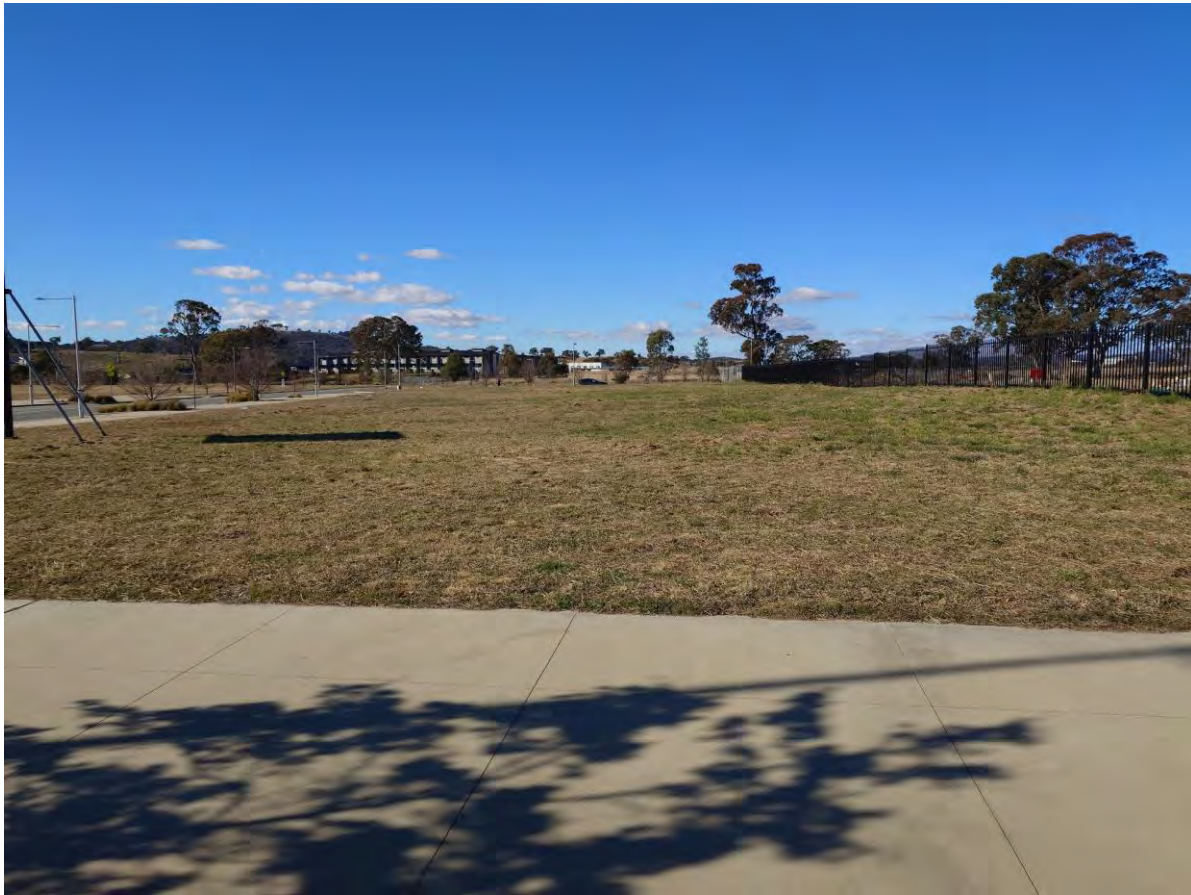
**Figure 35 – General View of the Site from the West Boundary Looking East**

The subject site is bounded by existing roadways that impede overland flows from entering the site. However, overland flows from the south in Block 5 Section 23 appear to be conveyed through the subject site. The area contributing to overland flow for the majority of the block is therefore assumed to be limited to the site area and a portion of Block 5 to the south. The current development that is taking place on Block 5 Section 23 is expected to change the dynamic of overland flow through the subject site due to regrading. The general topography and grading of the subject site together with that of the adjacent Block 5 Section 23 can be seen in Figure 35 below, which is a photo taken from the west boundary of Block 4 Section 23, looking east over the site.

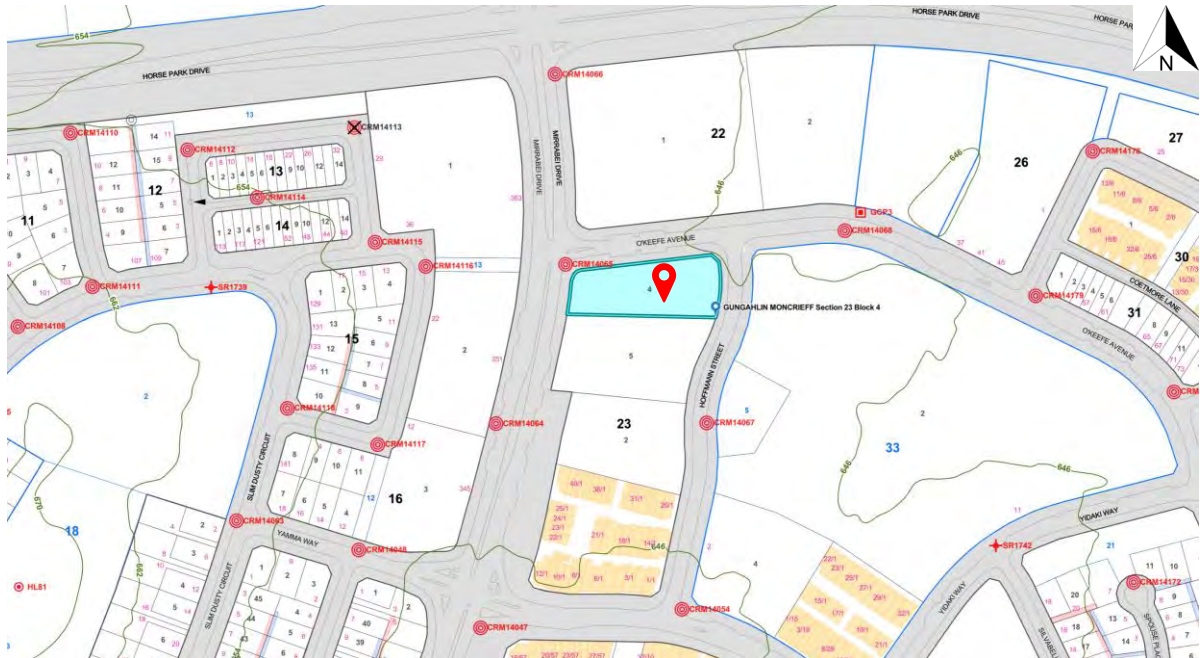
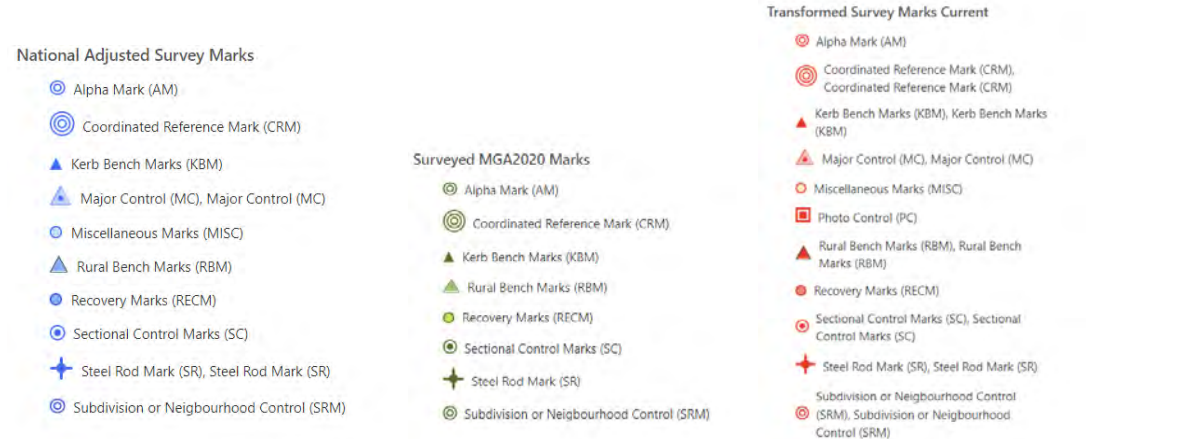
Figure 53 – Existing Survey Markers and Easements Surrounding the Site (ACTmapi, 2024)

Refer to Figure 53 for an extracted image from ACTmapi showing the location of this and other nearby survey markers and easements that are situated surrounding the site.

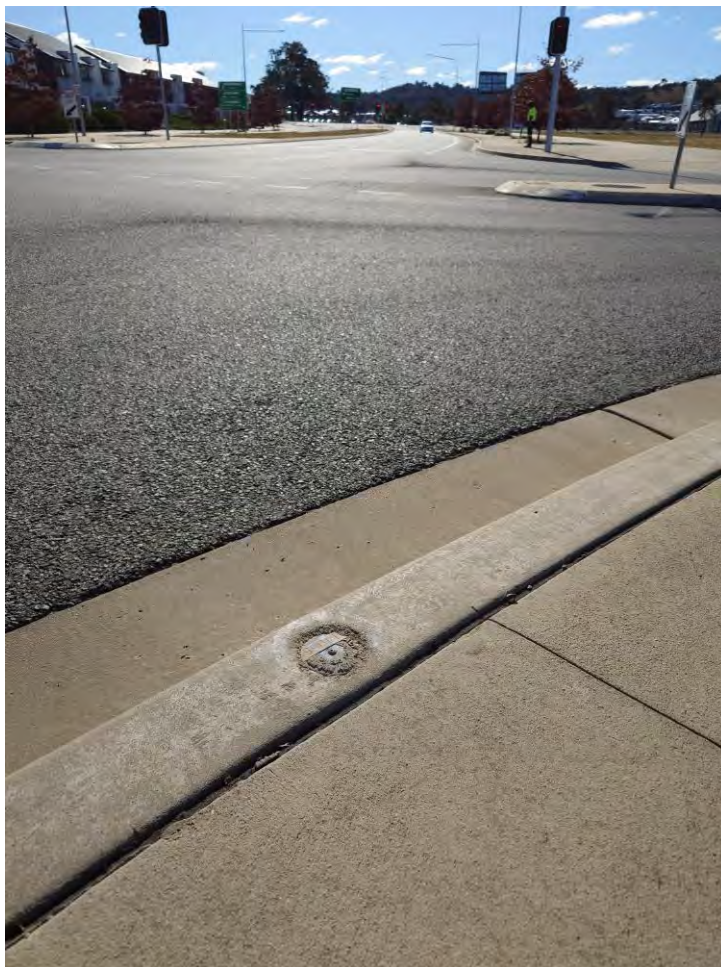
Figure 55 – Existing Kerb Survey Marker (CRM14065)

A search on ACTmapi indicates that there are several survey markers in proximity of the site. These include a coordinated reference markers (CRM14065) on the kerb near the intersection of O'Keefe Avenue and Mirrabai Drive, north east of the site. See Figure 55 below for a photo of the CRM kerb survey marker at this intersection.

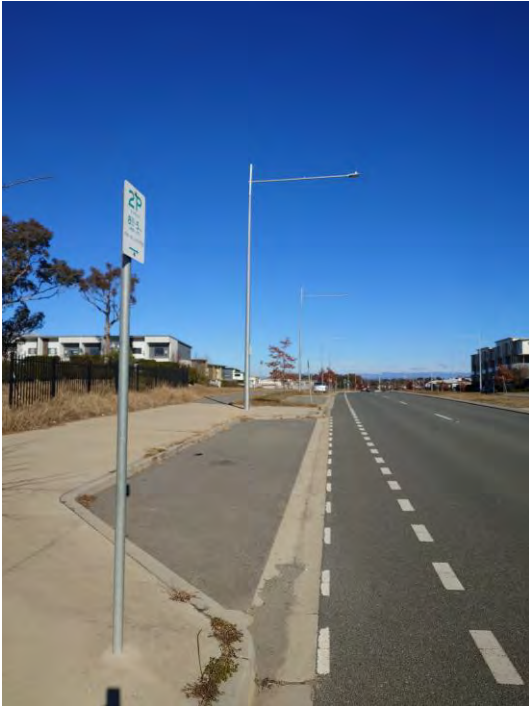
**Figure 73 – On Street Car Parking on Mirrabai Drive**

Additionally, 14 indented parking bays are available within 100 meters of the subject site along Mirrabai Drive. The parking bays on Mirrabai Drive are signposted as 2 hour parking. A sign showing this on Mirrabai Drive is provided in Figure 73 below.

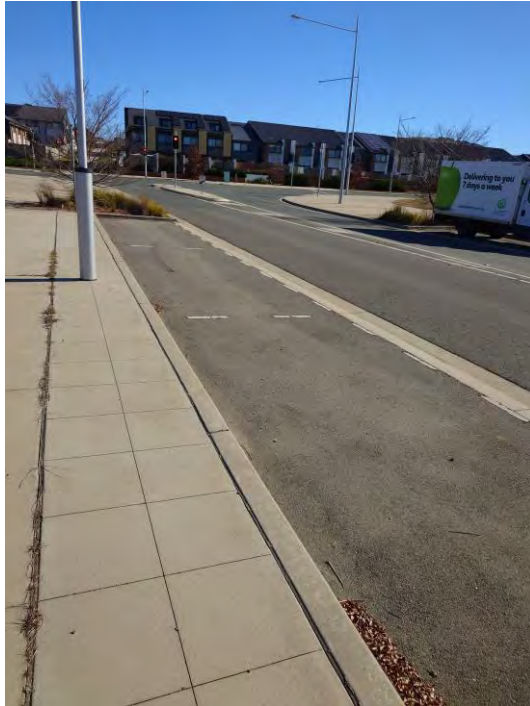
**Figure 75 – On Street Car Parking on O'Keefe Avenue**

Car parking is available on O’Keefe Avenue, north of the subject site, where 12 indented car parking bays are provided. These car parking spaces are signposted as 30 minute parking only. The photos in Figure 75 and Figure 76 show the on street parking bays in O’Keefe Street and Figure 74 shows the parking restriction sign for this parking.

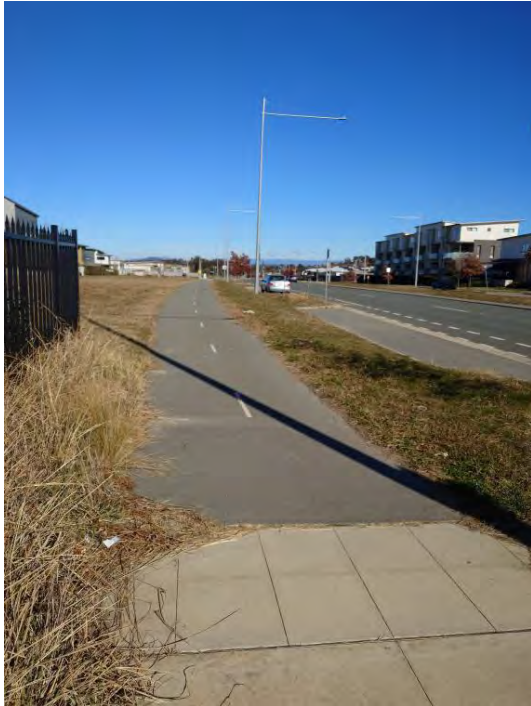
**Figure 78 – Shared Path in East Verge of Mirrabai Drive**

Drive, directly west of the site, features an approximately 2.0m wide concrete path. Beyond the intersection with O’Keefe Avenue, this path transitions into a fully paved verge. The fully paved verge in the east verge of Mirrabai Drive transitions to an approximately 2.5m wide asphaltic shared path, south east of the site. This shared path can be seen in Figure 78 below.

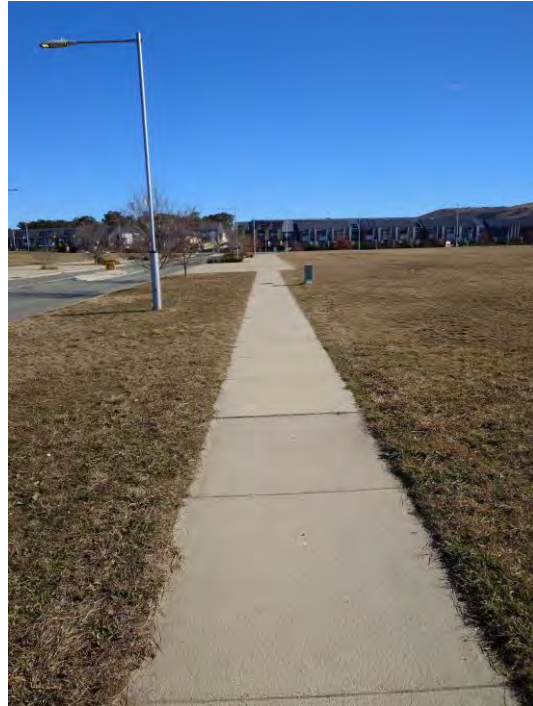
**Figure 80 – Path in Northern Verge of O'Keefe Avenue**

A central road median with a pedestrian refuge is situated near the north east corner of the site on O’Keefe Avenue, providing connectivity from the shared path in the west verge of Hoffmann Street to the fully paved verge in the northern part of O’Keefe Avenue. Beyond the intersection with Hoffmann Street, an approximately 1.5m wide concrete path continues to the east in the northern verge of O’Keefe Avenue. This path in the northern verge of O’Keefe Avenue can be seen in Figure 80 below.

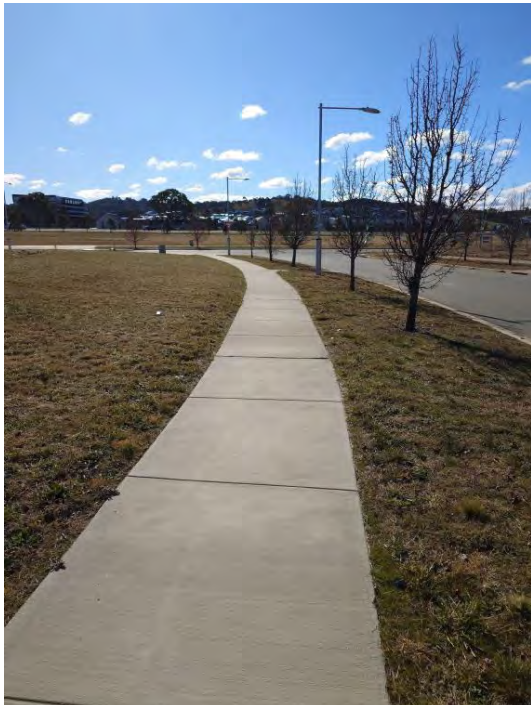
**Figure 79 – Footpath in West Verge of Hoffmann Street**

Hoffmann Street has an approximately 1.5m wide concrete footpath along its west verge, and an asphalt shared path, approximately 2.5m wide, in the east verge. This shared path in Hoffmann Street connects to another 2.5m wide asphalt shared path extending to the east along the southern verge of O’Keefe Avenue. See Figure 79 below for a photo of the path in the west verge of Hoffmann Street, adjacent the site.

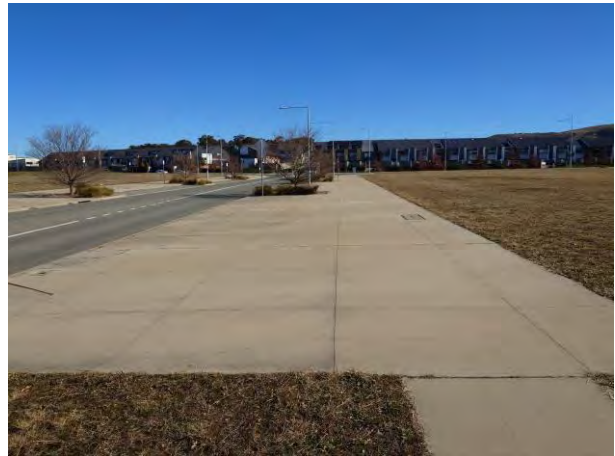
**Figure 81 – Fully Paved Verge North of Site in Southern Verge of O'Keefe Avenue**

Fully paved plain concrete verges are present along O'Keefe Avenue to the north and Mirrabai Drive to the west of the subject site. The photos in Figure 81 and Figure 82 provide a general view of these fully paved verges adjacent the subject site. In addition, a fully paved concrete verge extends along the northern verge of O'Keefe Avenue for the length of the subject site. The west verge of Mirrabai

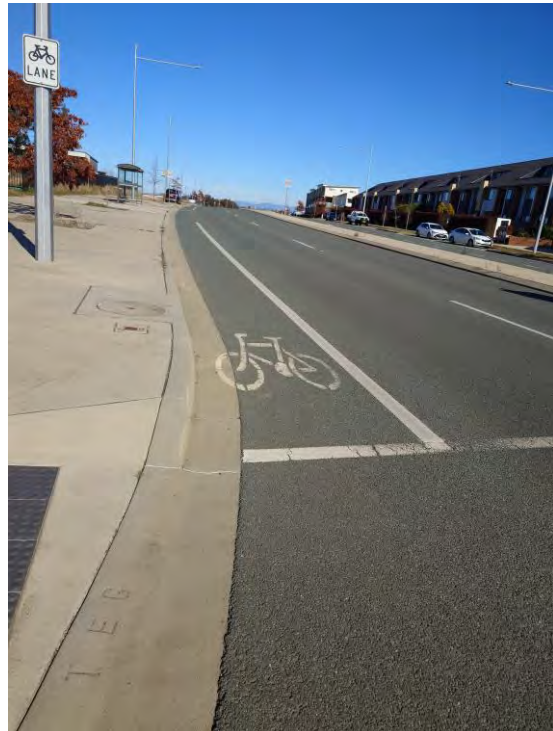
**Figure 83 – On Road Cycle Lane on Mirrabai Drive**

A signalised intersection at O’Keefe Avenue and Mirrabai Drive facilitates pedestrian and cyclist access, with on road cycle lanes, approximately 1.5 meters wide, available in both southbound and northbound carriageways of Mirrabai Drive. Refer to Figure 83 below for a photo of the southbound cycle lane on Mirrabai Drive, adjacent the site.

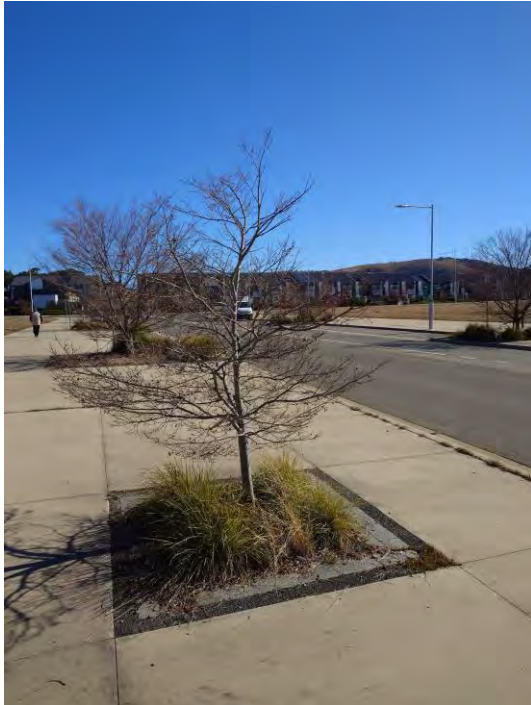
Figure 91 – O’Keefe Avenue Street Trees

- Street trees lining the southern and northern fully paved verges of O’Keefe Avenue are present north of the subject site. These trees were observed on site to be recently planted saplings. See Figure 91 and Figure 94 below for photos of these trees taken north of the site.

A tree assessment has not been undertaken on the site, however, if any potential damaging activities will occur to any of the existing trees surrounding the site, a tree assessment will need to be carried

out by an accredited arborist in conjunction with a tree survey. Following a tree assessment, the findings should be provided to the ACT Tree Protection Unit for comment/validation.

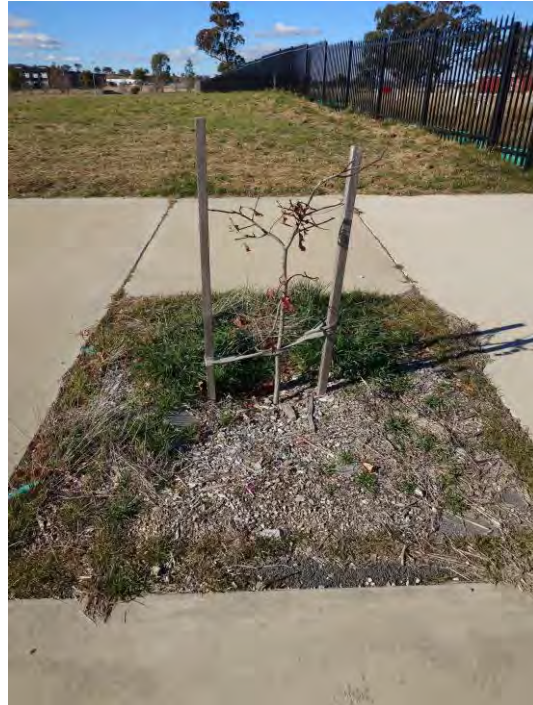
Figure 93 –Street Tree South West of Site

- Deciduous street trees were also observed in the east and west verges of Mirrabei Drive. The trees that were in the east verge of Mirrabei Drive, adjacent the subject site were young saplings of varying condition, planted within the fully paved street verge. See Figure 92 and Figure 93 below for photos that capture the condition and maturity of these trees.

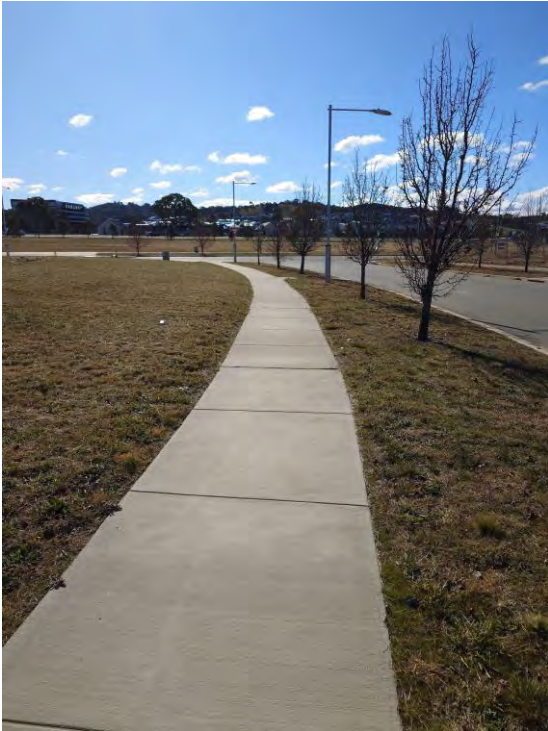
**Figure 95 – Street Trees in West Verge of Hoffmann Street**

- Deciduous street trees are planted in the east and west verges of Hoffmann Street. These trees are relatively young and can be seen in Figure 95 adjacent the subject site’s east boundary.

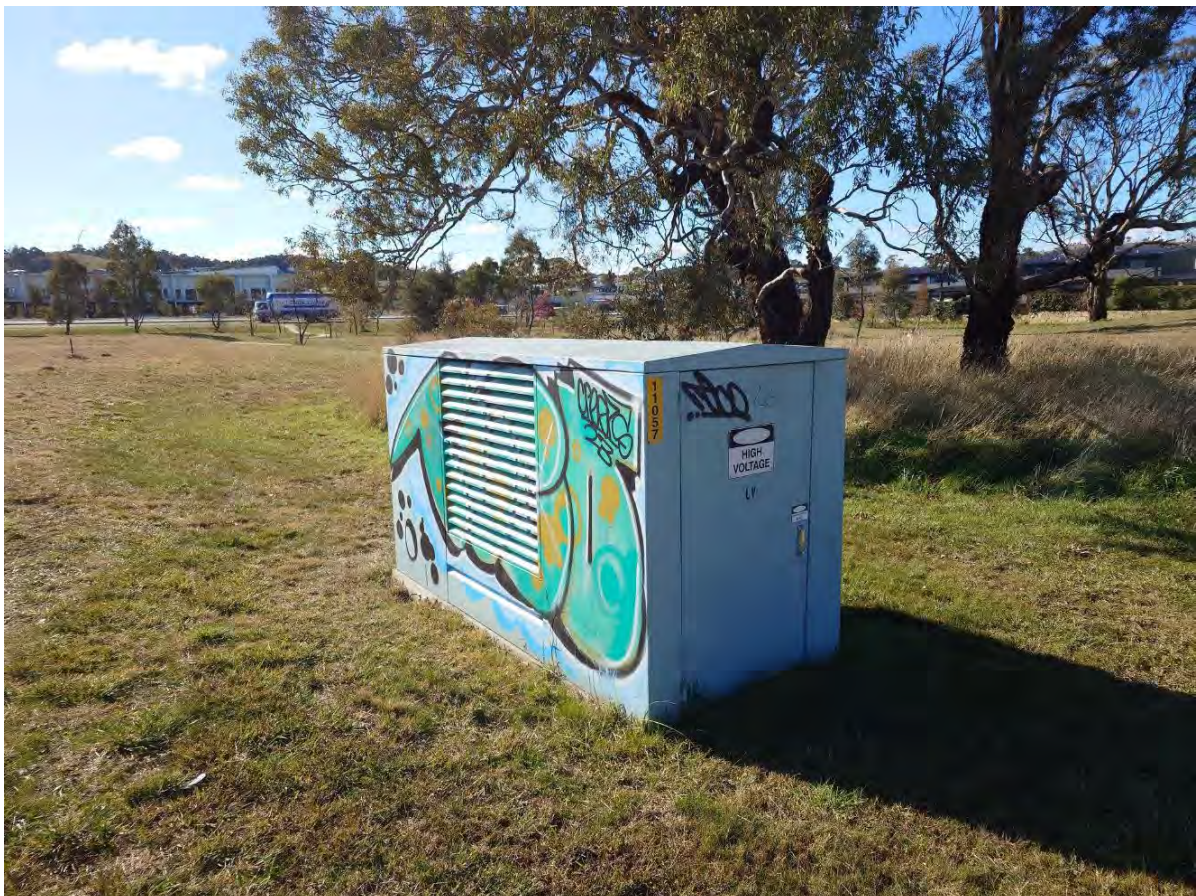
For your information, I have noted a substation in the open space area to the north east of the site, with photo below.

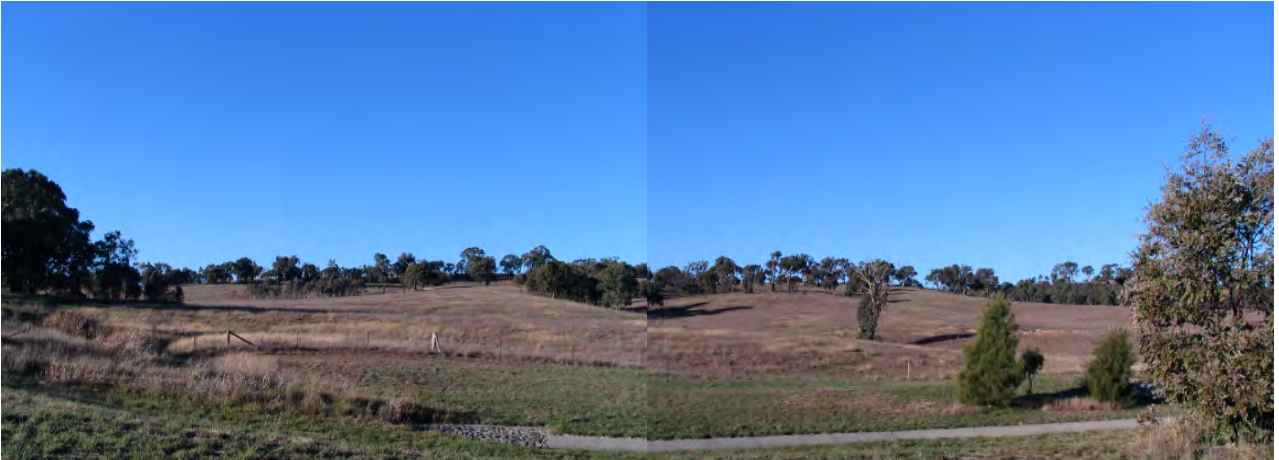
***Photograph No. 1 - Taken from Mirrabei Drive looking northeast to the ridgeline within the proposed Reserve.***

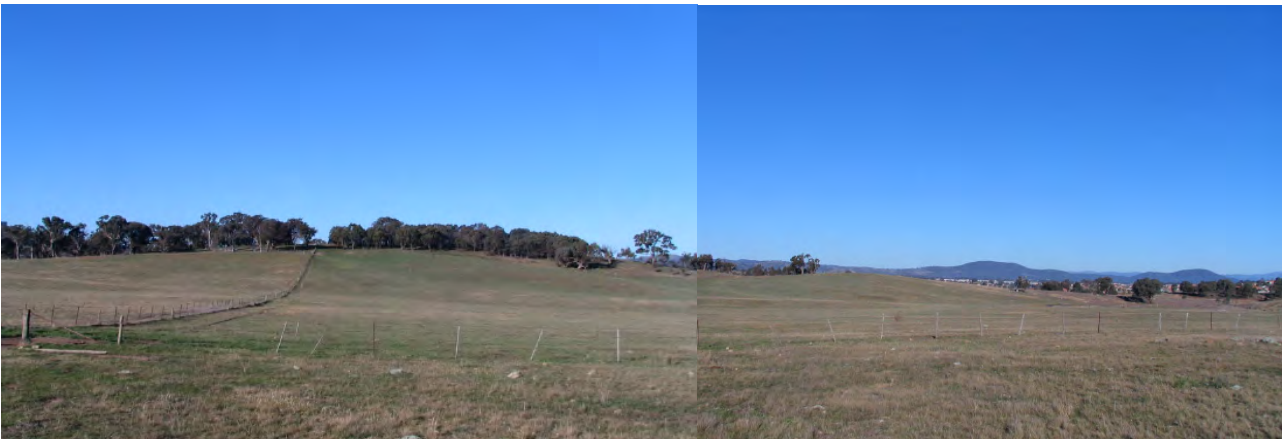
***Photograph No. 2 - Taken from the future Horse Park Drive looking east towards the woodland vegetation within the proposed Reserve.***
