# SITE CLASSIFICATION REPORT SUMMARY

**BLOCK:** 1                      **SECTION:** 15                      **SUBURB:** Wright  
**JOB No:** 46231.13                      **DATE:** October 2011  
**CLIENT:** Cardno Young Pty Ltd

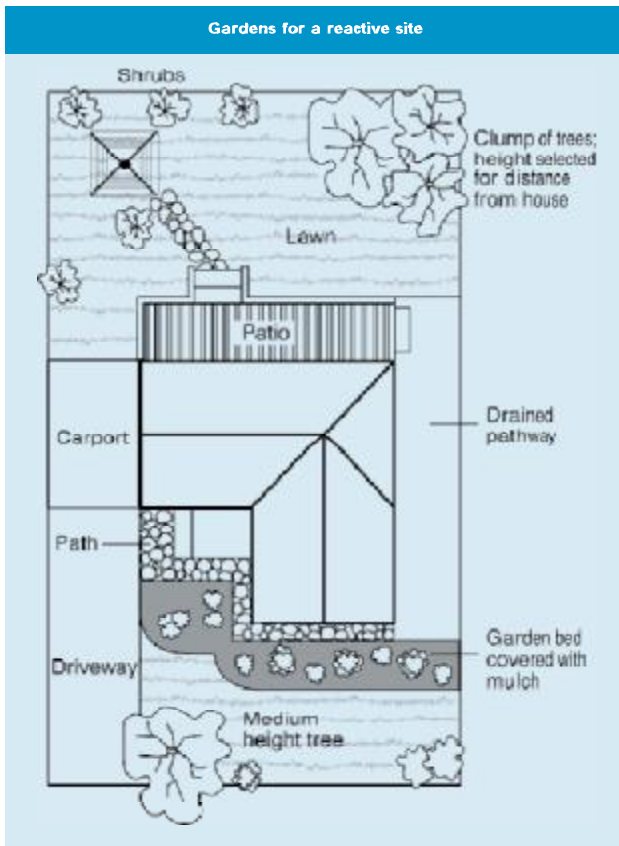
### CLASSIFICATION OF DAMAGE WITH REFERENCE TO WALLS

Description of typical damage and required repair	Approximate crack width limit (see Note 3)	Damage category
Hairline cracks	<0.1 mm	0
Fine cracks which do not need repair	<1 mm	1
Cracks noticeable but easily filled. Doors and windows stick slightly	<5 mm	2
Cracks can be repaired and possibly a small amount of wall will need to be replaced. Doors and windows stick. Service pipes can fracture. Weathertightness often impaired	5–15 mm (or a number of cracks 3 mm or more in one group)	3
Extensive repair work involving breaking-out and replacing sections of walls, especially over doors and windows. Window and door frames distort. Walls lean or bulge noticeably, some loss of bearing in beams. Service pipes disrupted	15–25 mm but also depend on number of cracks	4

In general, most cracking found in masonry walls is a cosmetic nuisance only and can be kept in repair or even ignored. The table below is a reproduction of Table C1 of AS 2870.
