Investigation Summary Report

Client	Suburban Land Agency	Project No.	231354.01
Project	Proposed Development	Date	2 September 2024
Address	Block 4 Section 23, Moncrieff ACT	Reference	R.001.Rev0

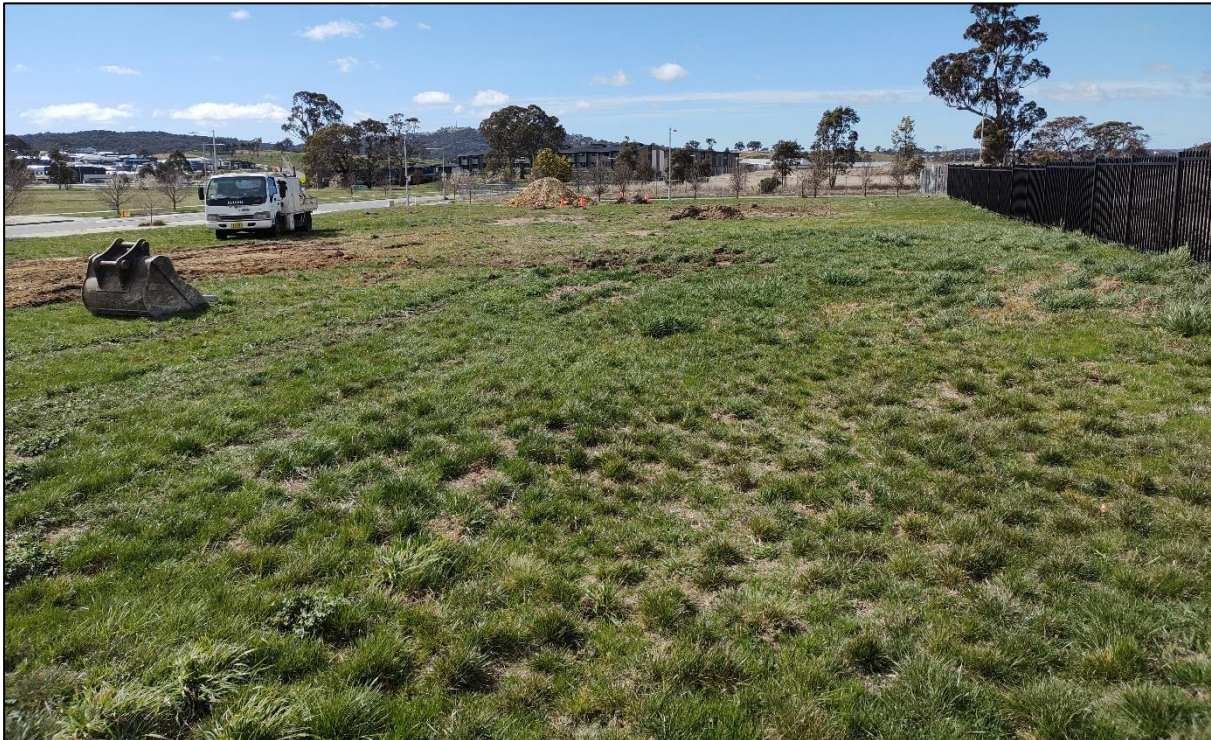
At the time of site investigation, the block was clear and vacant, with a metal fence located along the southern boundary of the block. Grassy vegetation was growing across most of the block, while tree saplings were located within the verge along the northern, eastern and western boundaries of the block. A large sign was located within the north-western corner of the block.

Figure 1: View looking north-east across the block.

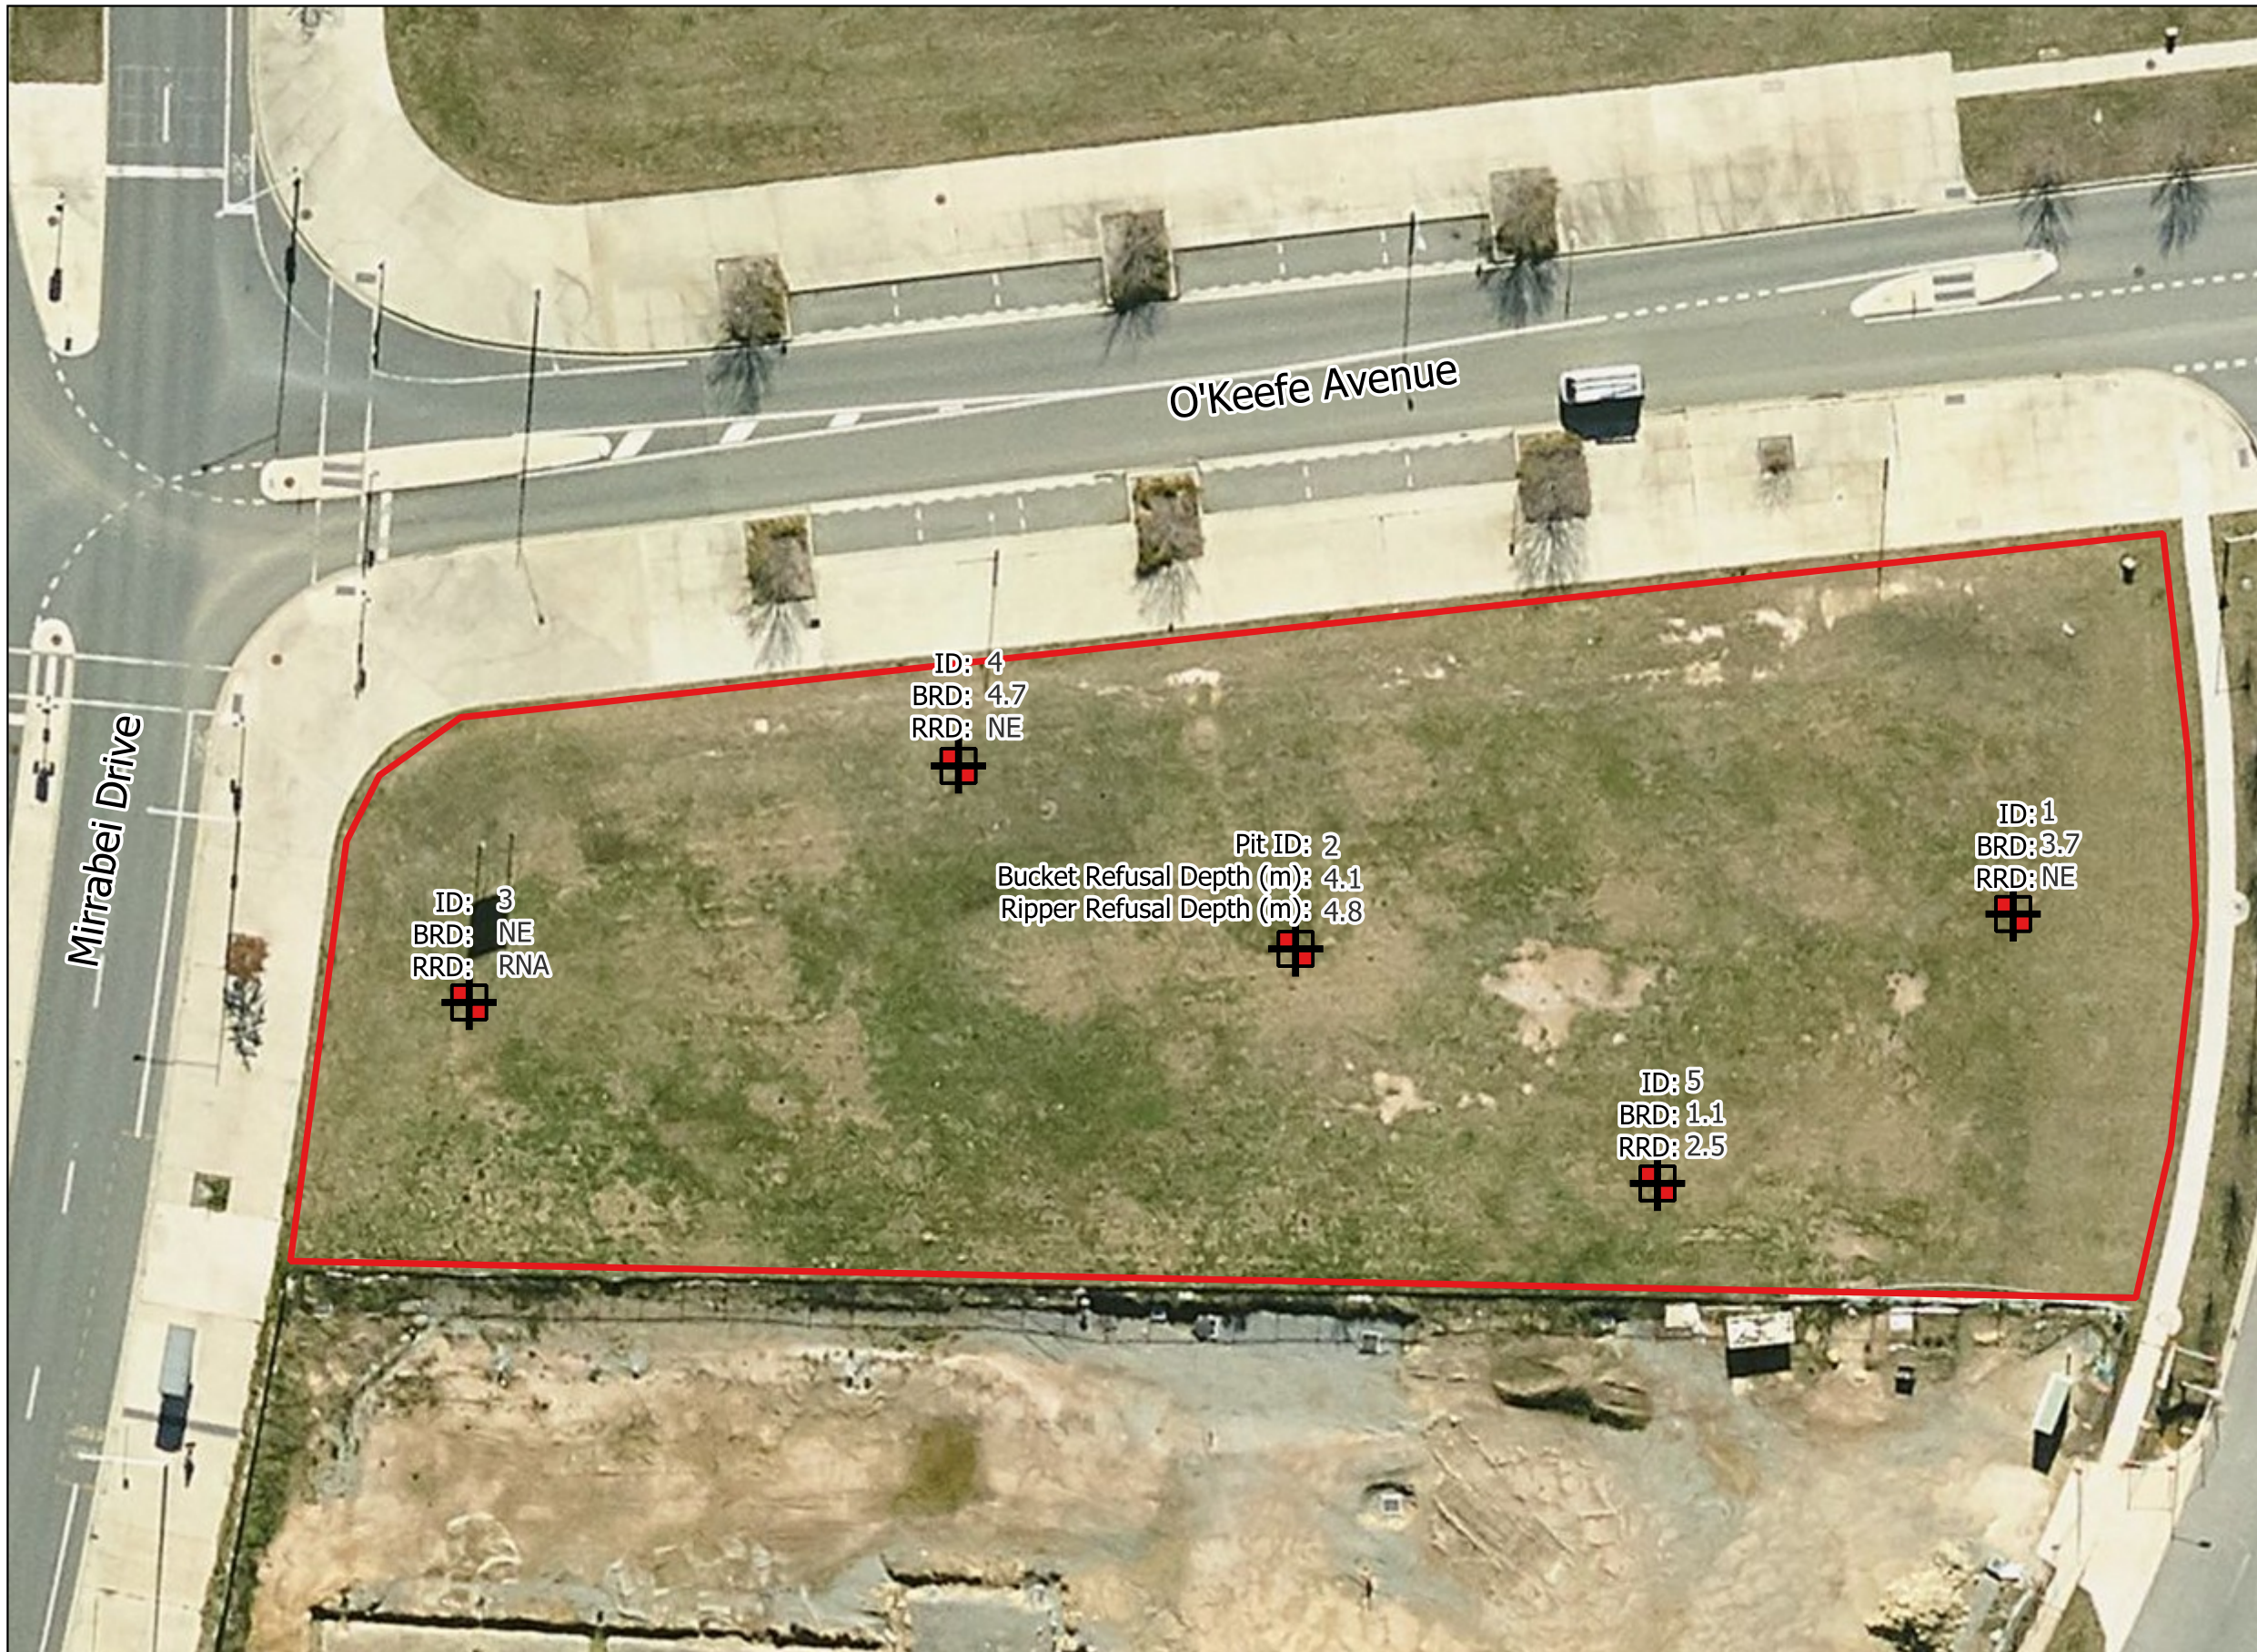
The test pit coordinates (MGA2020) and reduced levels (AHD) were determined on site using an Emlid Reach RS2 dGPS, typically accurate to ± 0.5 m. However, it is noted that Douglas are not registered surveyors, and as such all coordinates must be considered approximately only. The test locations are shown on Drawing 1 attached to this report.

Approximate Test Pit Location
- NE: Not Encountered
- RNA: Ripper Not Attached

NOTE:
 1. Drawing projection in GDA2020 / MGA zone 55, adapted from aerial imagery from MetroMap dated 26.07.2024.
 2. Test locations are approximate only and were located using differential GPS.
